Citation: Watts GR, Amir K and Pheasant R (2017) Investigation of noise and disturbance from vehicles crossing cattle grids and examination of options for mitigation. *Acoustics Bulletin*. 42(1): 42-50.

Investigations of noise and disturbance from vehicles crossing cattle grids and examination of options for mitigation

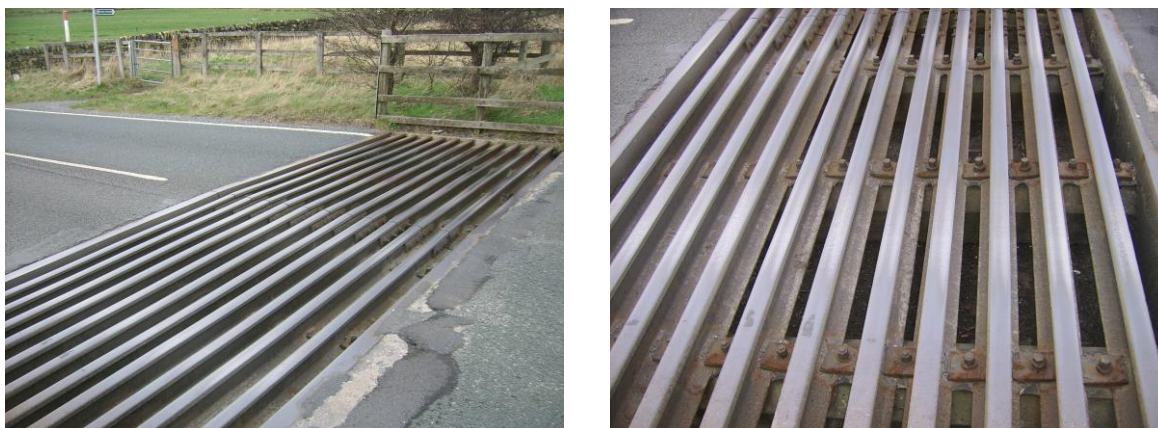
Figure 1 shows an installation on the entrance to Baildon Moor (Site Baildon B) north of Bradford in West Yorkshire. It consists of 11 rectangular topped steel bars of width 75 mm set at right angles to the road at 200 mm centres.

Figure 1: Cattle grid installation on Baildon Moor (site Baildon B)

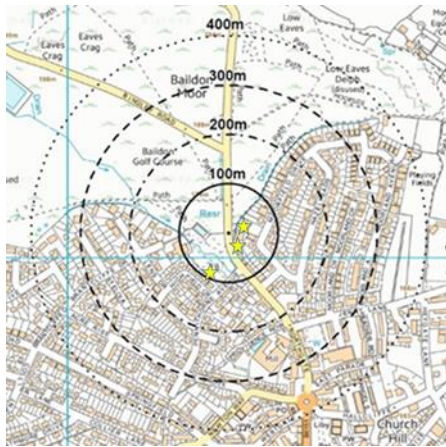
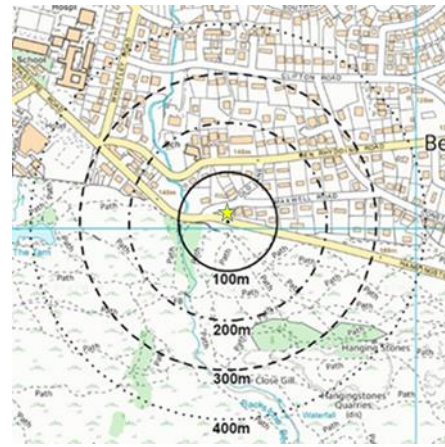
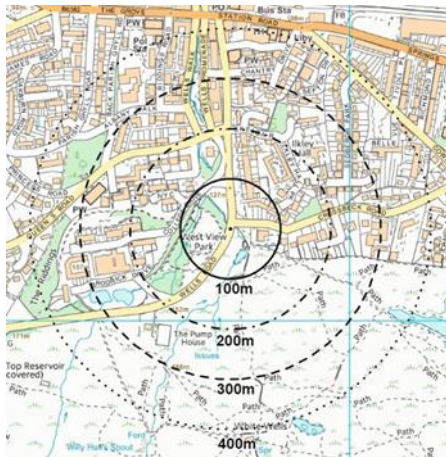
To determine the size and nature of the problem questionnaires were posted to homes within an approximate radius of 150m from two cattle grids located near to residential areas i.e. sites Baildon A and Ilkley A. The questionnaire is given in Appendix A and was provided with a postage paid reply envelope. There was an invitation to allow measurements at their homes if they thought this was appropriate. In all measurements near the facades of four such homes were carried out. The distances from the cattle grids ranged from 7.7m to 122m. Figures 2 show maps of the cattle grid sites situated close to dwellings with concentric circles centred on the cattle grids to indicate distance. The four measurement positions are marked with asterisks.

Figure 2: Site maps of cattle grids where noise disturbance is likely

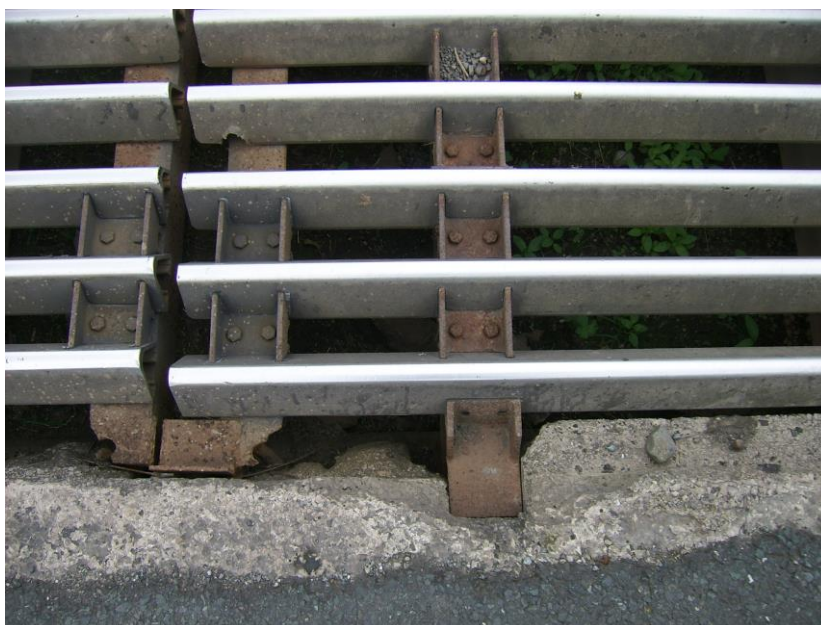
There was some variation in average peak levels obtained from passing traffic between sites at Baildon and Ilkley but differences were small. Some of this variation will be due to sampling errors as the variation observed with the test vehicle was much smaller as can be seen in Figure 3. Detailed differences in design would also have contributed but no conclusions can be drawn without further investigations. However, at the Sedbergh sites, levels were considerably higher and the character of the sound indicated considerable rattle noise from multiple impacts. Observations at this site revealed that the whole grid moved as the grid came under load from passing vehicles and it is likely that multiple impacts of the loose grid with supporting structures produced the observed high maximum levels. Figure 8 shows damage to the concrete frame supporting the grid that allowed significant movement during loading.

Figure 8: Damage to concrete support frame at Sedbergh B site
